MERRIMACK RIVER BASIN
MEREDITH NEW HAMPSHIRE

MEREDITH RESERVOIR DAM
N.H.00308

PHASE I INSPECTION REPORT
NATIONAL DAM INSPECTION PROGRAM

APRIL, 1979

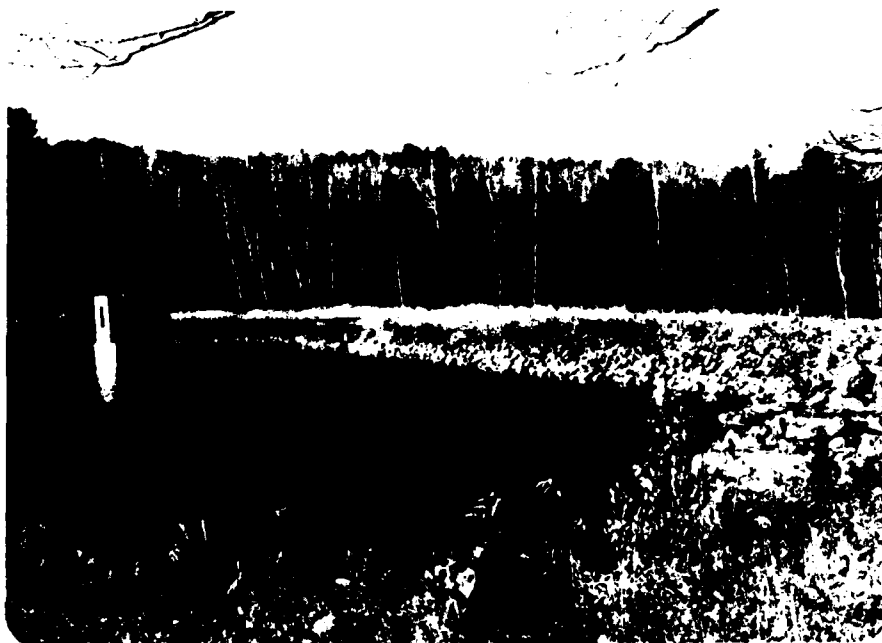
The control tower is located approximately 30 feet from the upstream dam embankment and is connected to the embankment via a steel girder service bridge. The control tower and service bridge are in good condition with the exception of the bridge abutment at the dam embankment which has settled and cracked (see Photo 9). The control tower concrete foundation received a 6-inch gunite coating in recent years.

#1. VIEW OF EARTH DAM AND CONTROL TOWER

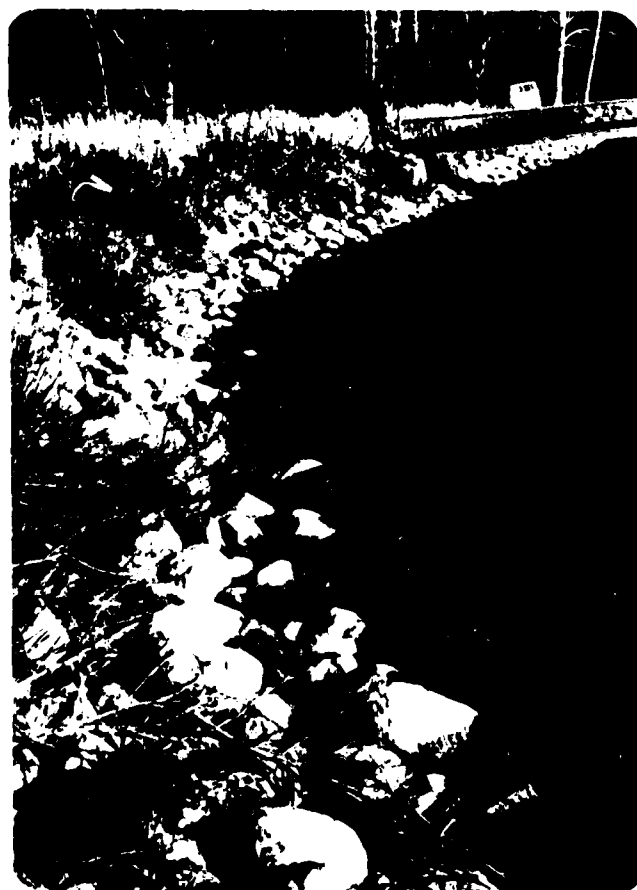
The downstream slope is approximately 1.5H:1V, while the upstream slope is somewhat steeper at 1H:1V. The water level at the time of inspection was approximately 1.3 feet below the spillway crest and therefore a complete visual inspection of the upstream slope could not be performed. The upper portion which could be viewed indicated a uniform riprap facing which was in good condition.

#2. VIEW OF UP-
STREAM DAM
EMBANKMENT

1. Repair the spalled and cracked concrete on the spillway walls and floor.
2. Repair the operating valves in the control tower.
3. Perform an inspection of the upstream dam embankment at low water conditions.

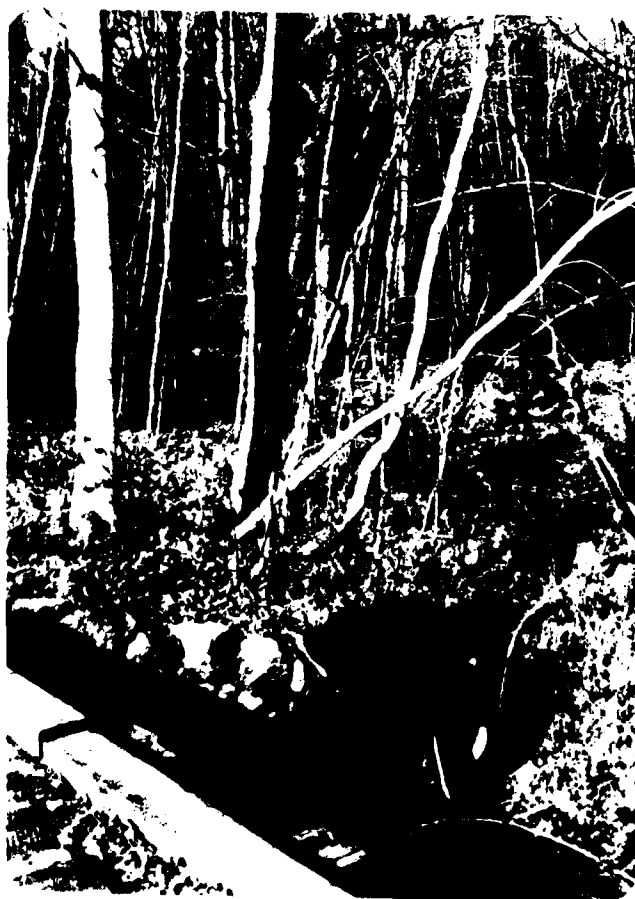
The concrete sections of the spillway structures are in poor condition. Most of the concrete is either cracked or spalled with major spalling occurring on the left training wall facing. There were no signs of significant leakage through the spillway structure during inspection, but leakage may be present during higher water levels.

#6. VIEW OF LEFT
SPILLWAY TRAINING
WALL AND TREES ON
EMBANKMENT

2. The trees and bushes growing on the dam should be removed yearly.
3. The existing tree stumps on the downstream slope should be inspected yearly for indications of seepage in their vicinity.
4. The wet area downstream of the dam should be observed periodically to detect any possible seepage flows.
5. The spillway should be subject to maintenance every two years. This would include repairs to the stone training walls, and patching of any cracked and spalled concrete. The first maintenance should be performed within one year.
6. Establish a formal warning system.
7. Maintain all gates in operational condition.
